Re: Remedial Activities and Site Closure Report
 7700 Earhart Boulevard Facility
 New Orleans, Louisiana
 Agency Interest No.: 1275

Remedial Activities and Site Closure Report

***7700 Earhart Boulevard Facility
New Orleans, Louisiana***

Agency Interest No. 1275

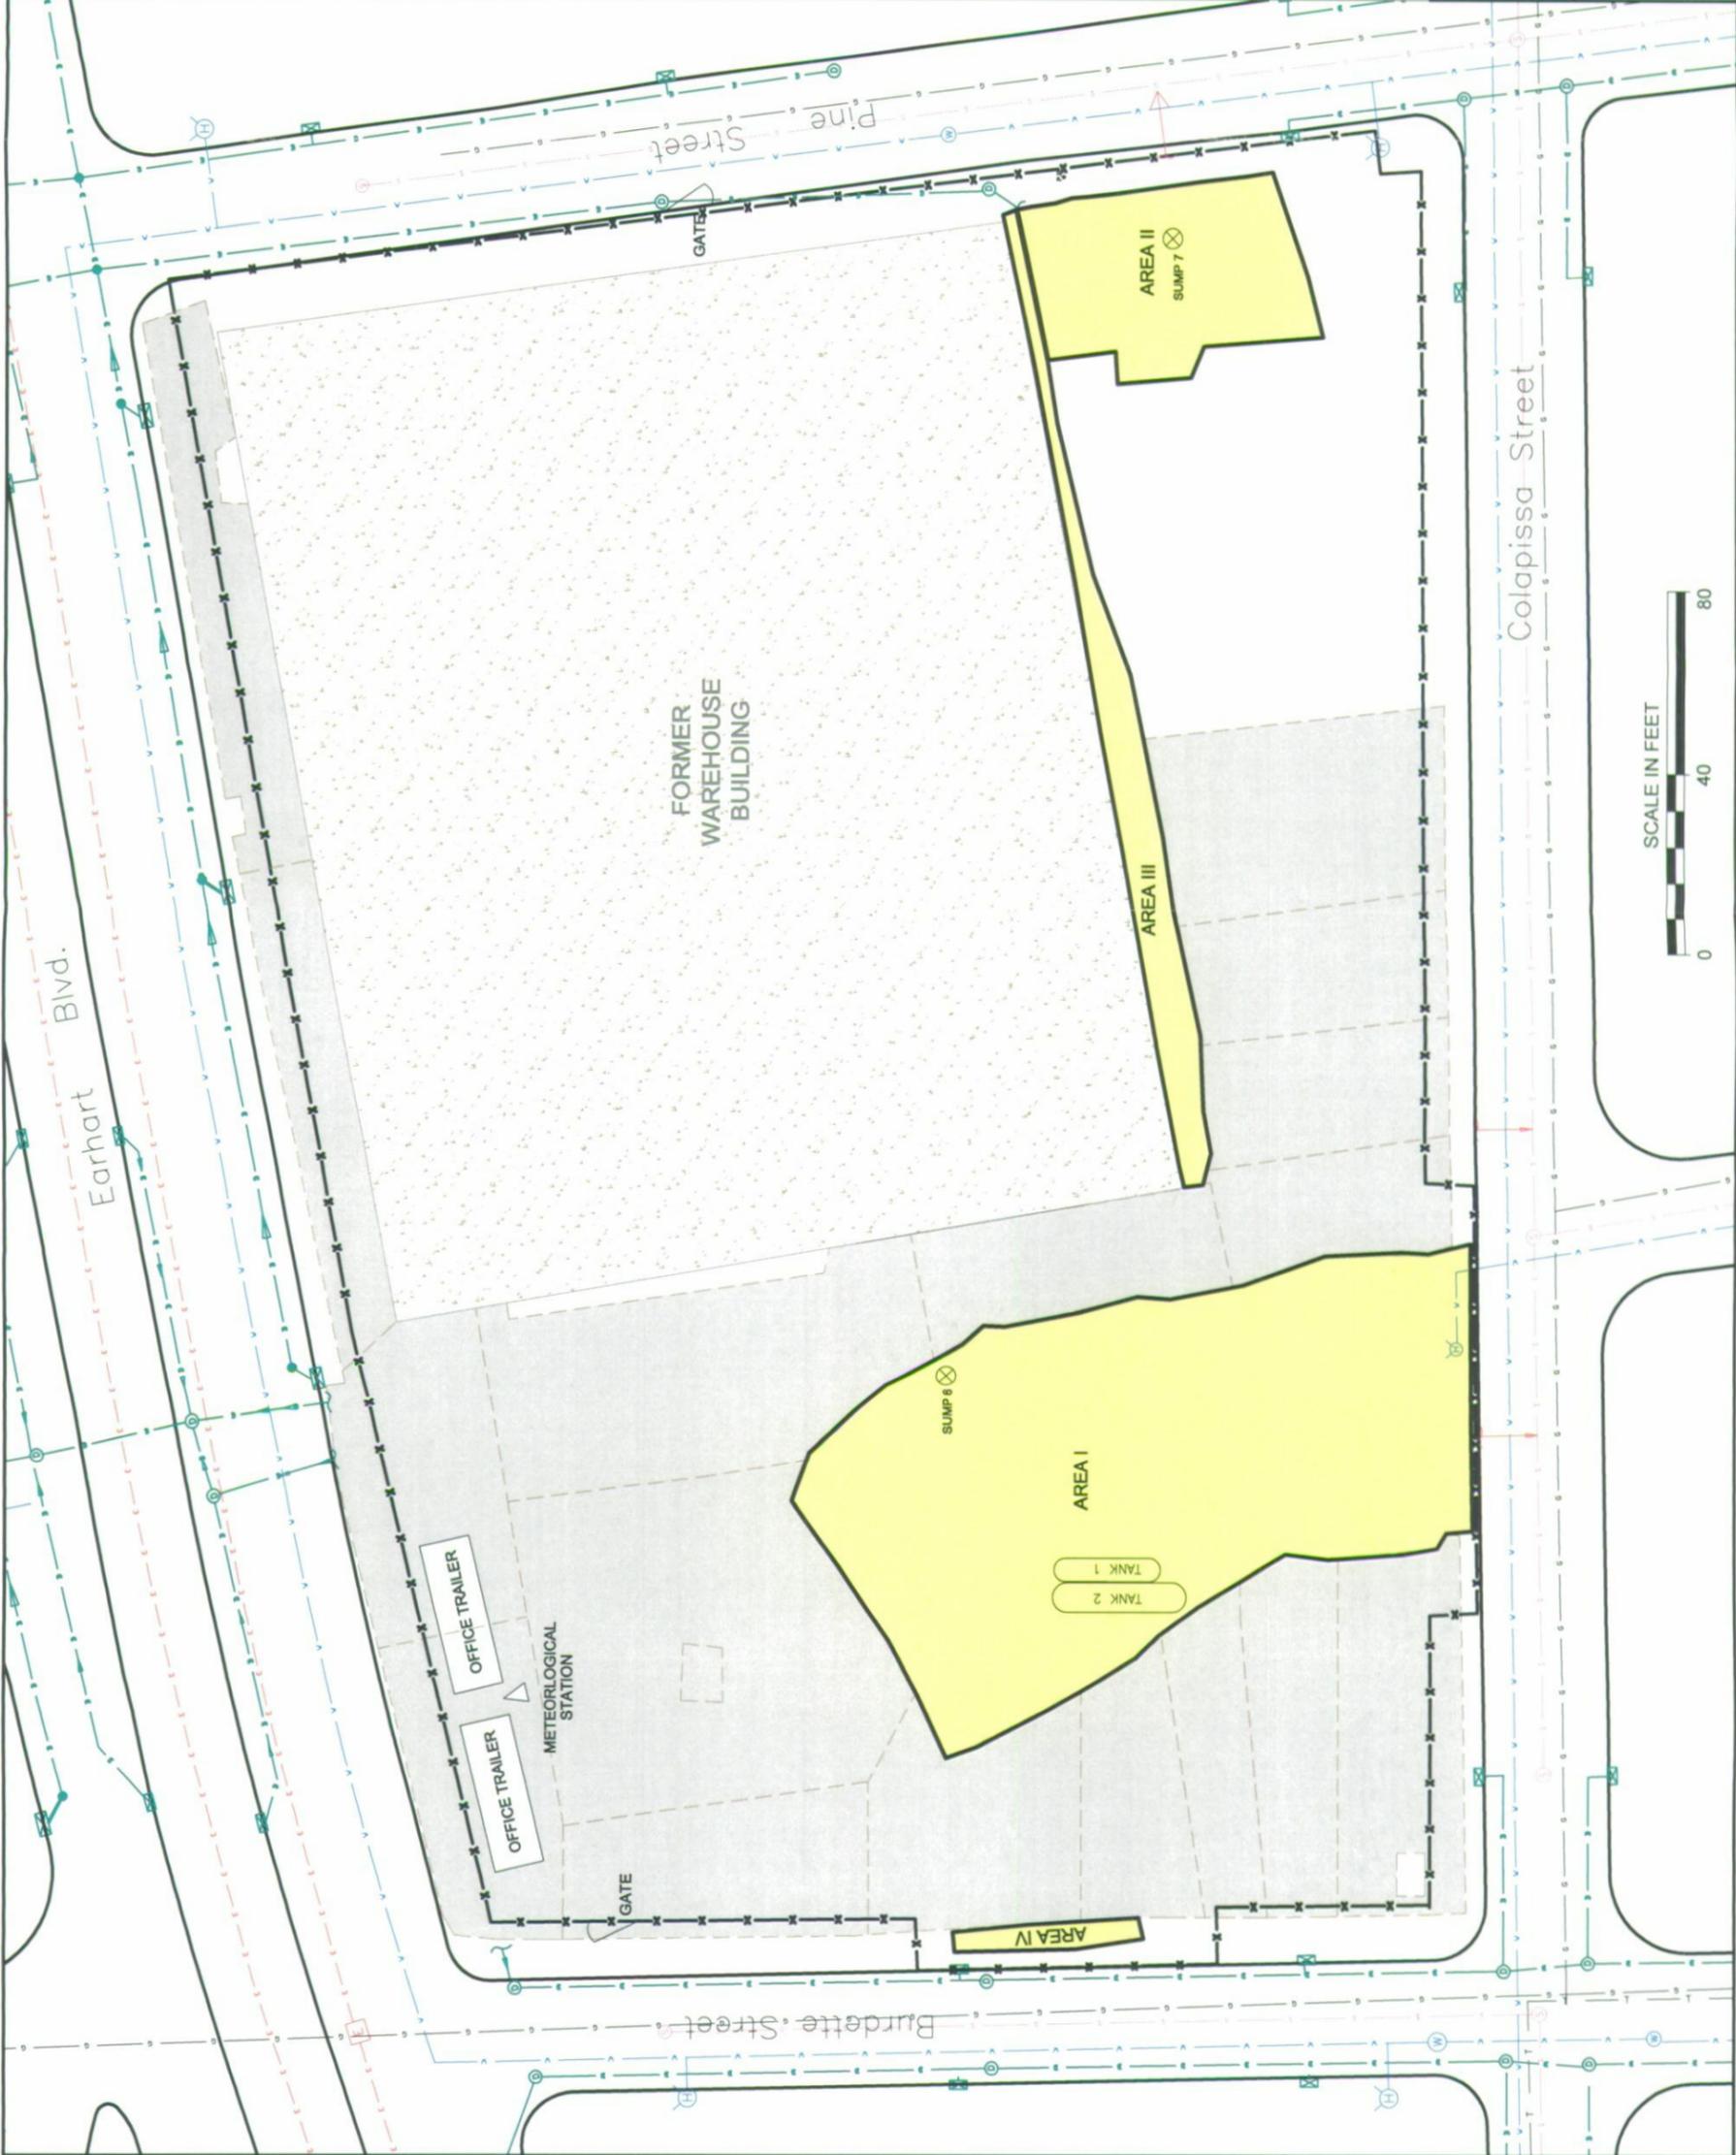
FIGURE 1-2

The Site is situated on an approximately 2.7 acre tract of land located in New Orleans, Louisiana. The facility lies within a residential and light industrial district in the city and is bounded by Earhart Boulevard, Burdette, Pine, and Colapissa Streets (Figure 1-1). The facility coordinates are approximately 29° 57' 32" north latitude and 90° 06' 42" west longitude. The facility is currently not occupied and is situated on land squares 461 and 462 as shown on Figure 1-1. A layout of the facility illustrating site conditions prior to remedial activities is presented on Figure 1-2.

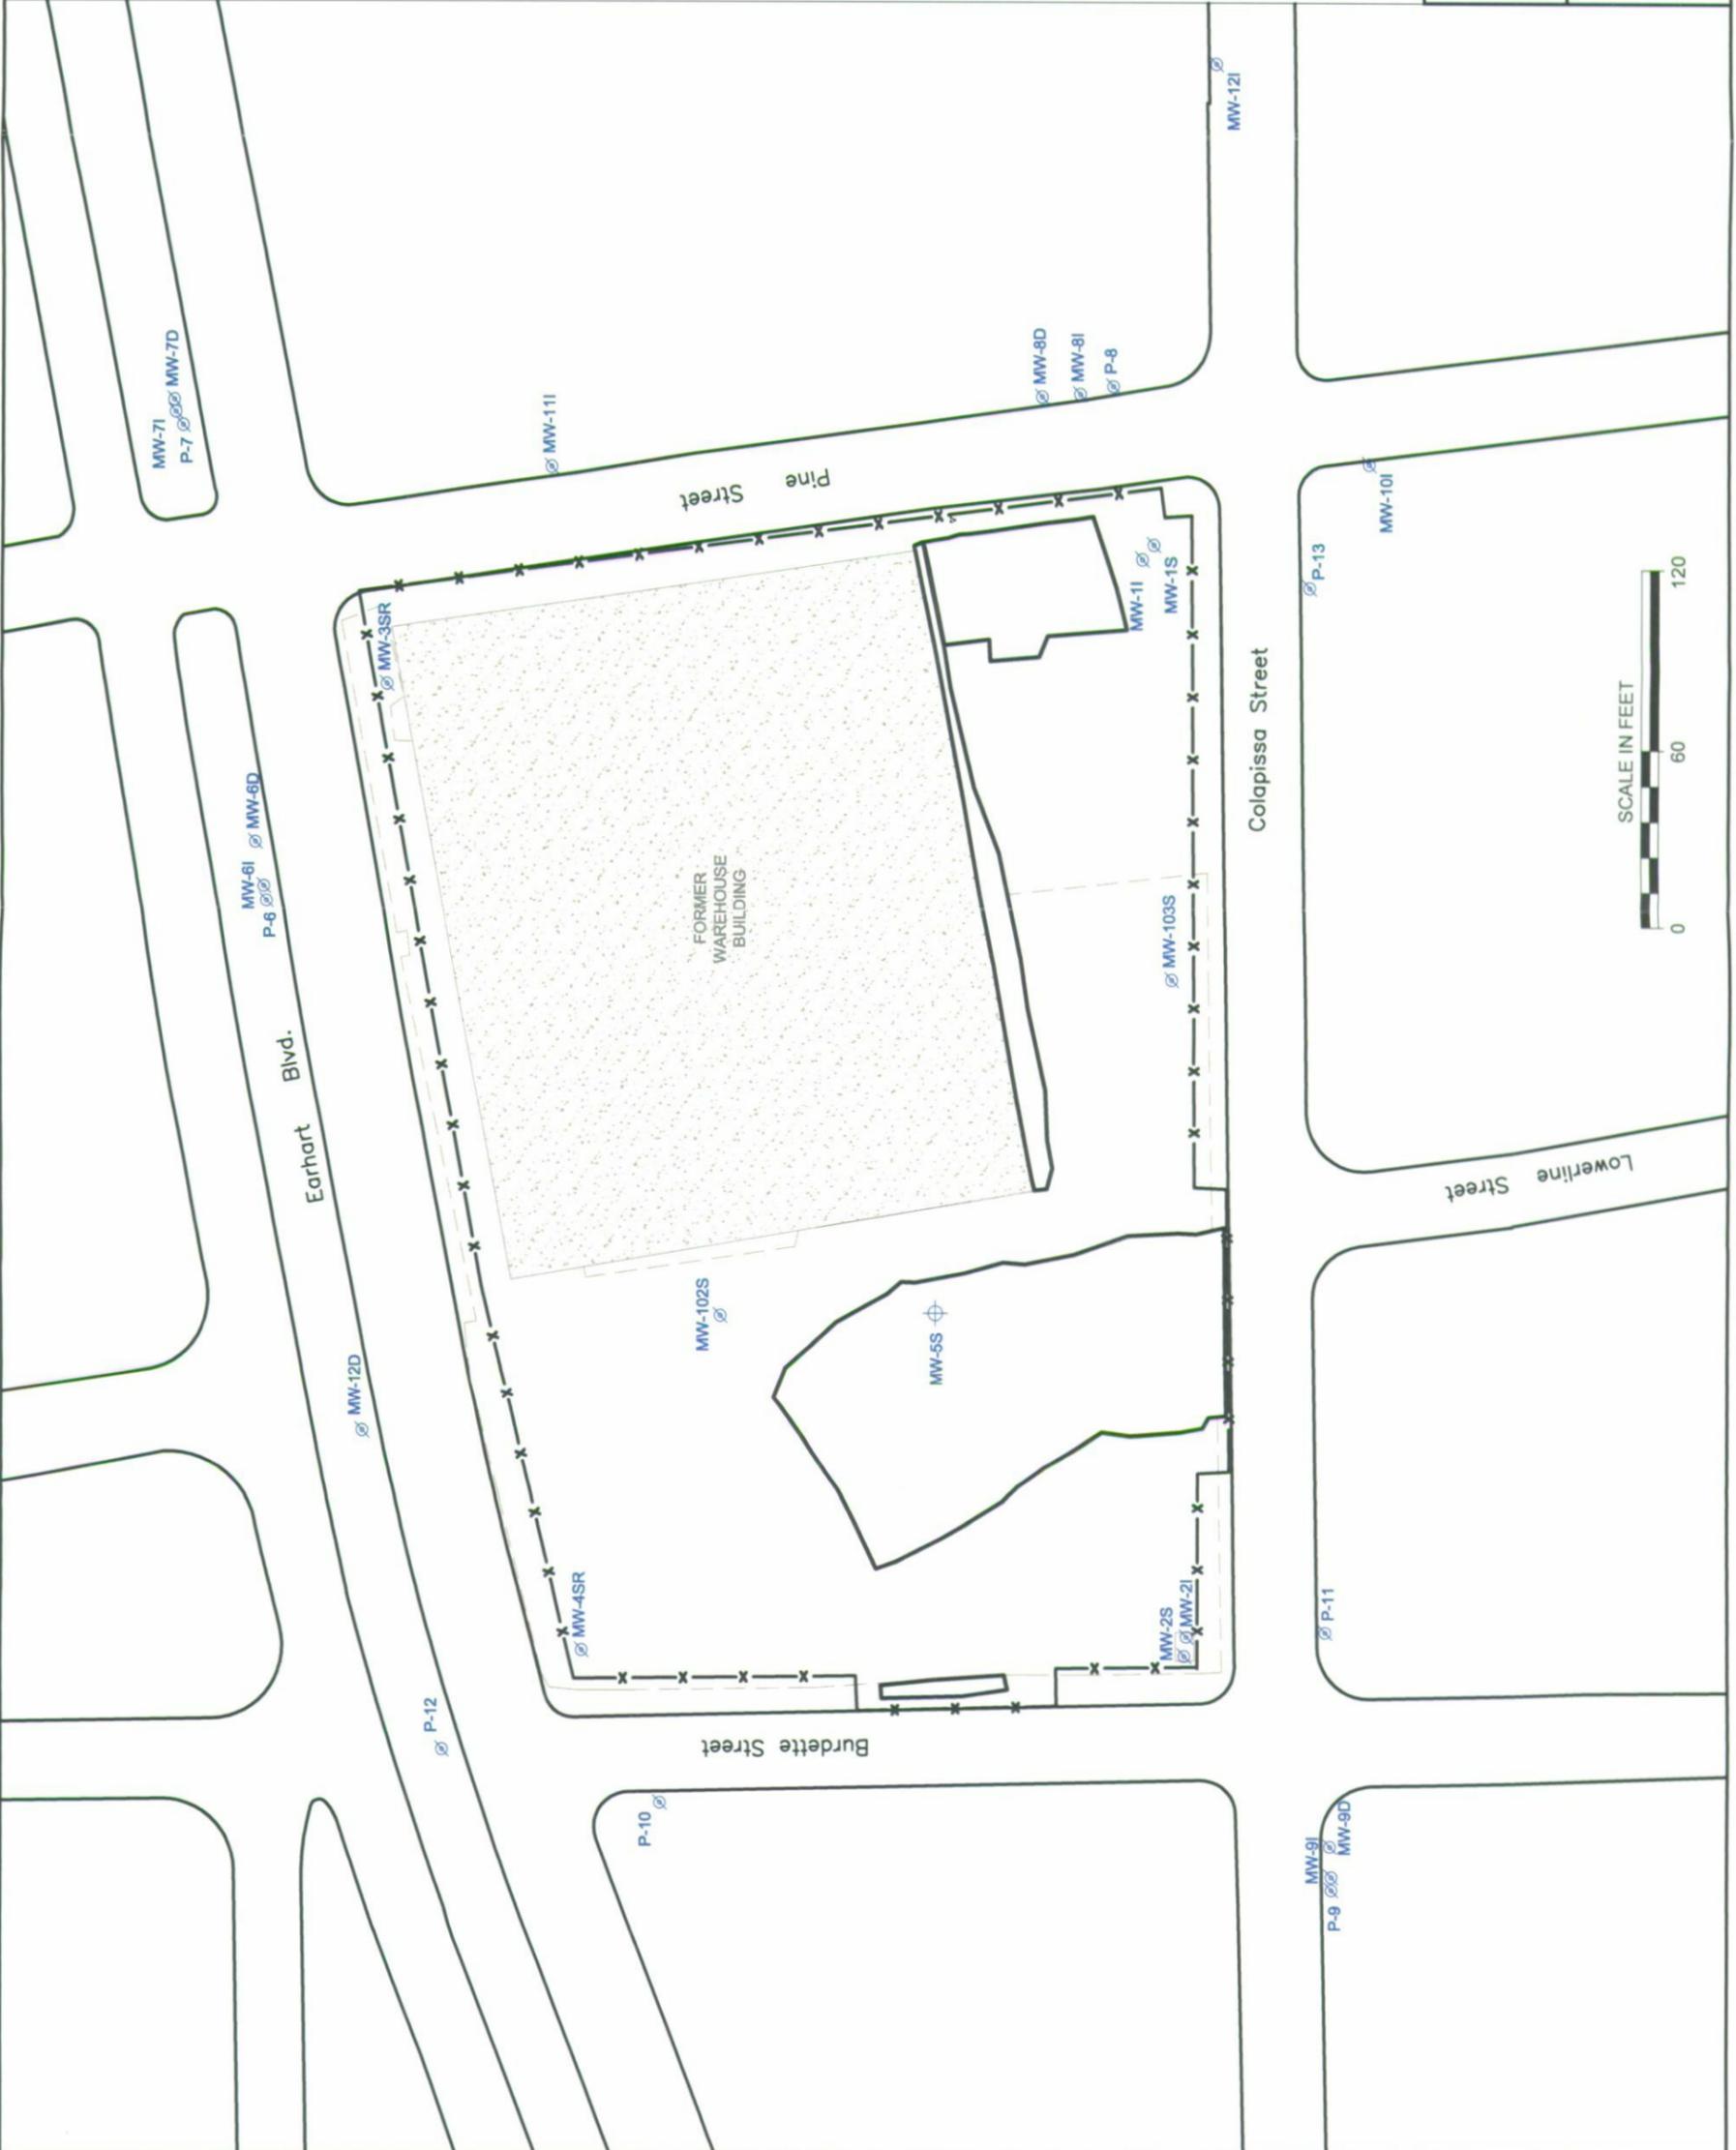
FIGURE 3-1
PIEZOMETER AND WELL LOCATIONS MAP
 REMEDIAL ACTIVITIES REPORT

DECOMMISSIONED MONITOR AND/OR PIEZOMETER WELL LOCATIONS

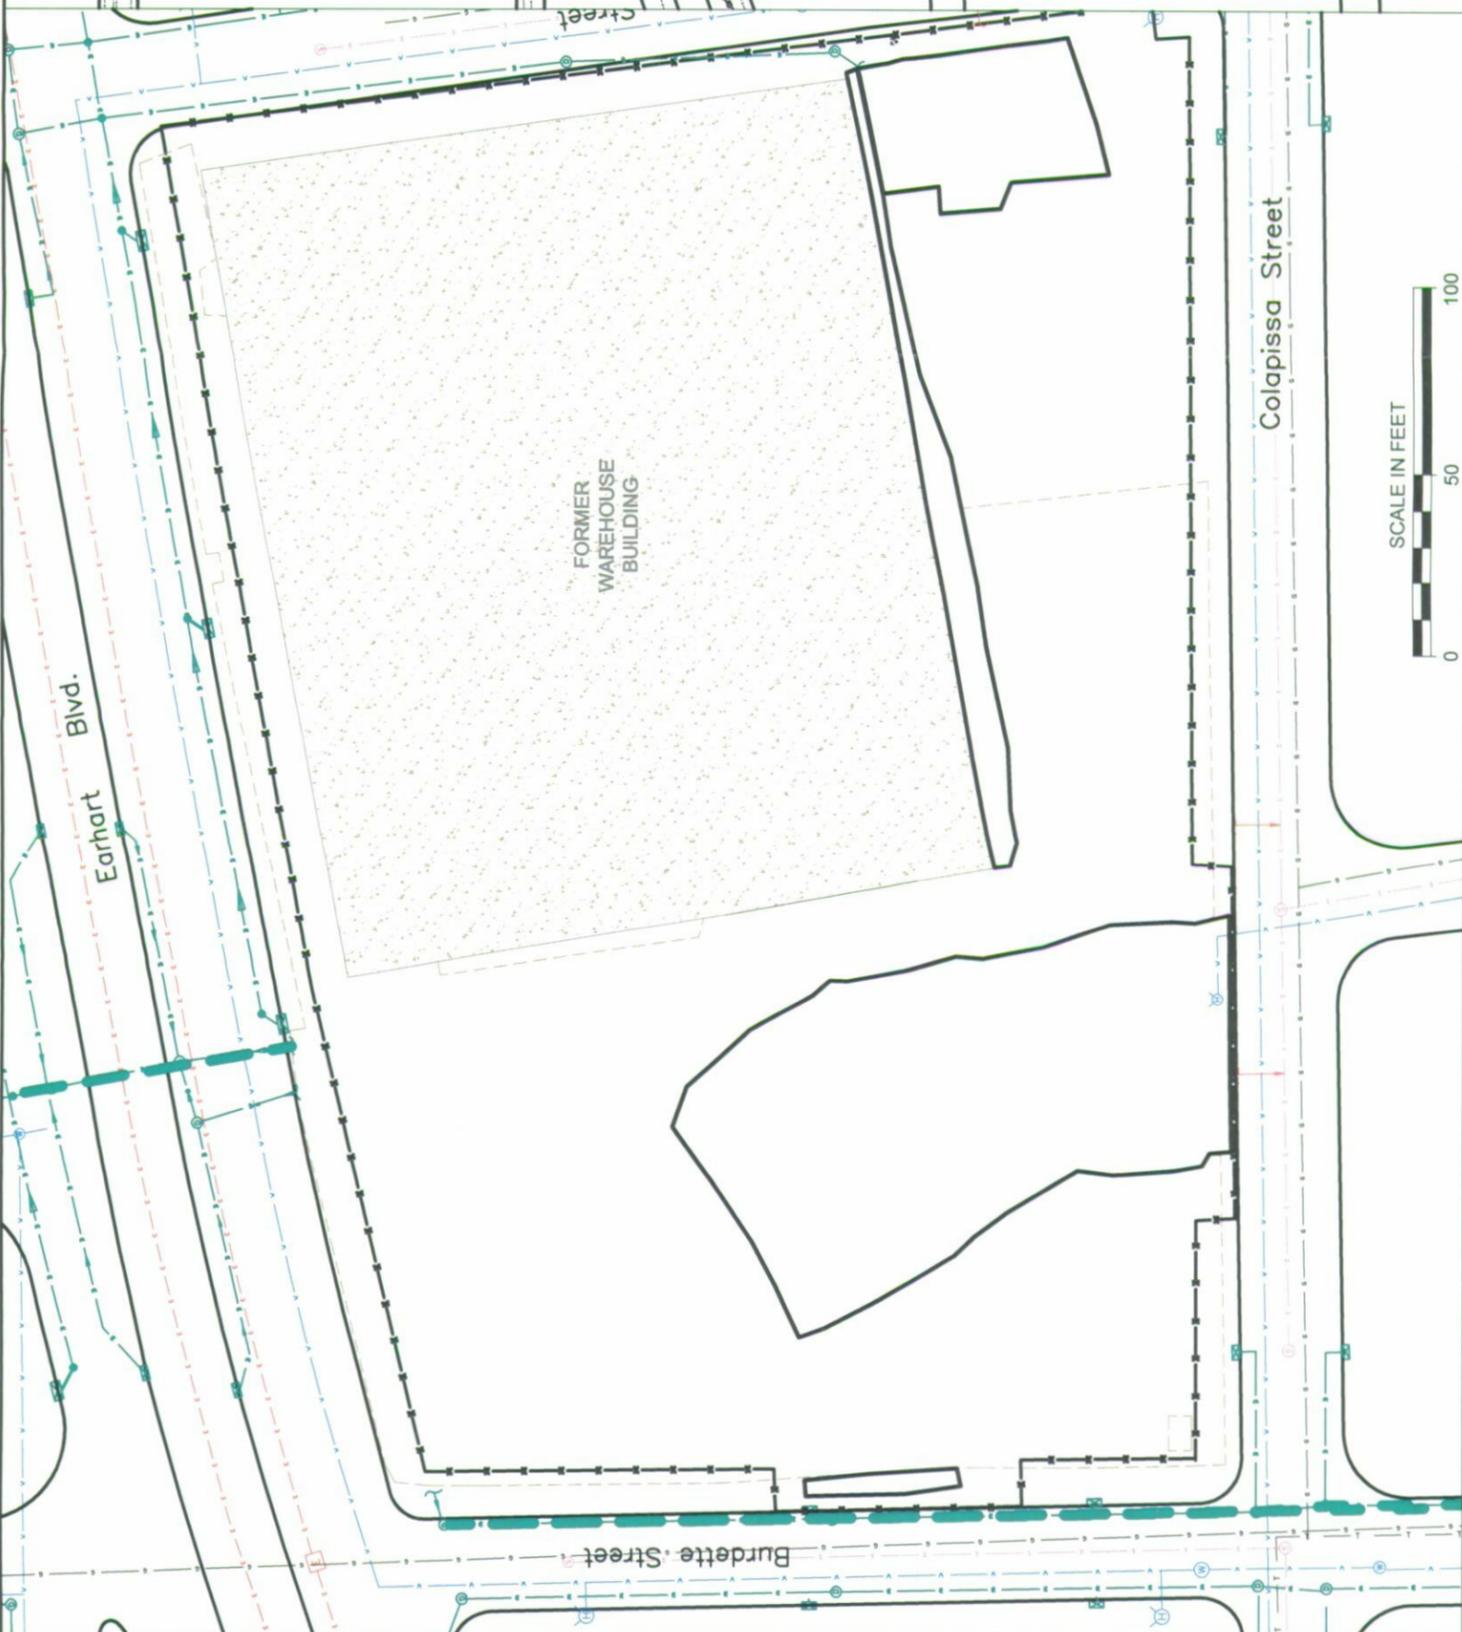
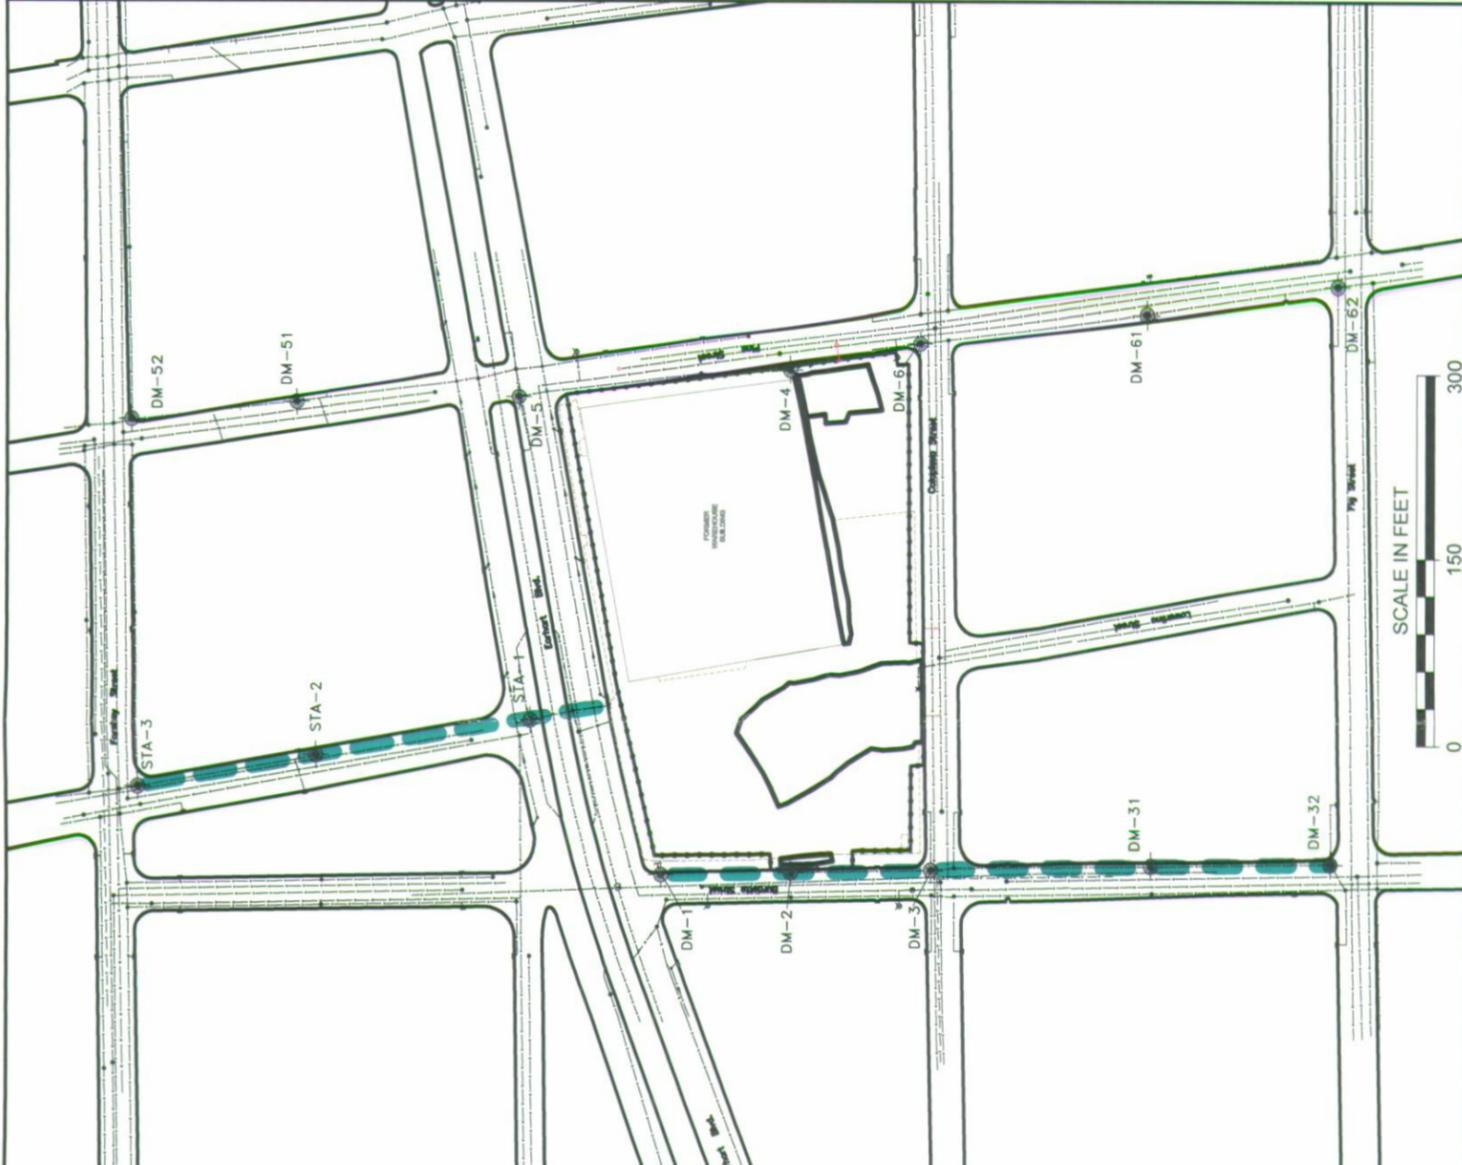
FIGURE 3-3
EXCAVATION SEQUENCING MAP
 REMEDIAL ACTIVITIES REPORT

- DM-32 STORM DRAIN SAMPLE POINTS
- ELECTRICAL
- STORM DRAIN
- SEWER
- WATER
- X — FENCE
- GAS
- CLEANED AND FLUSHED STORM DRAIN LINES

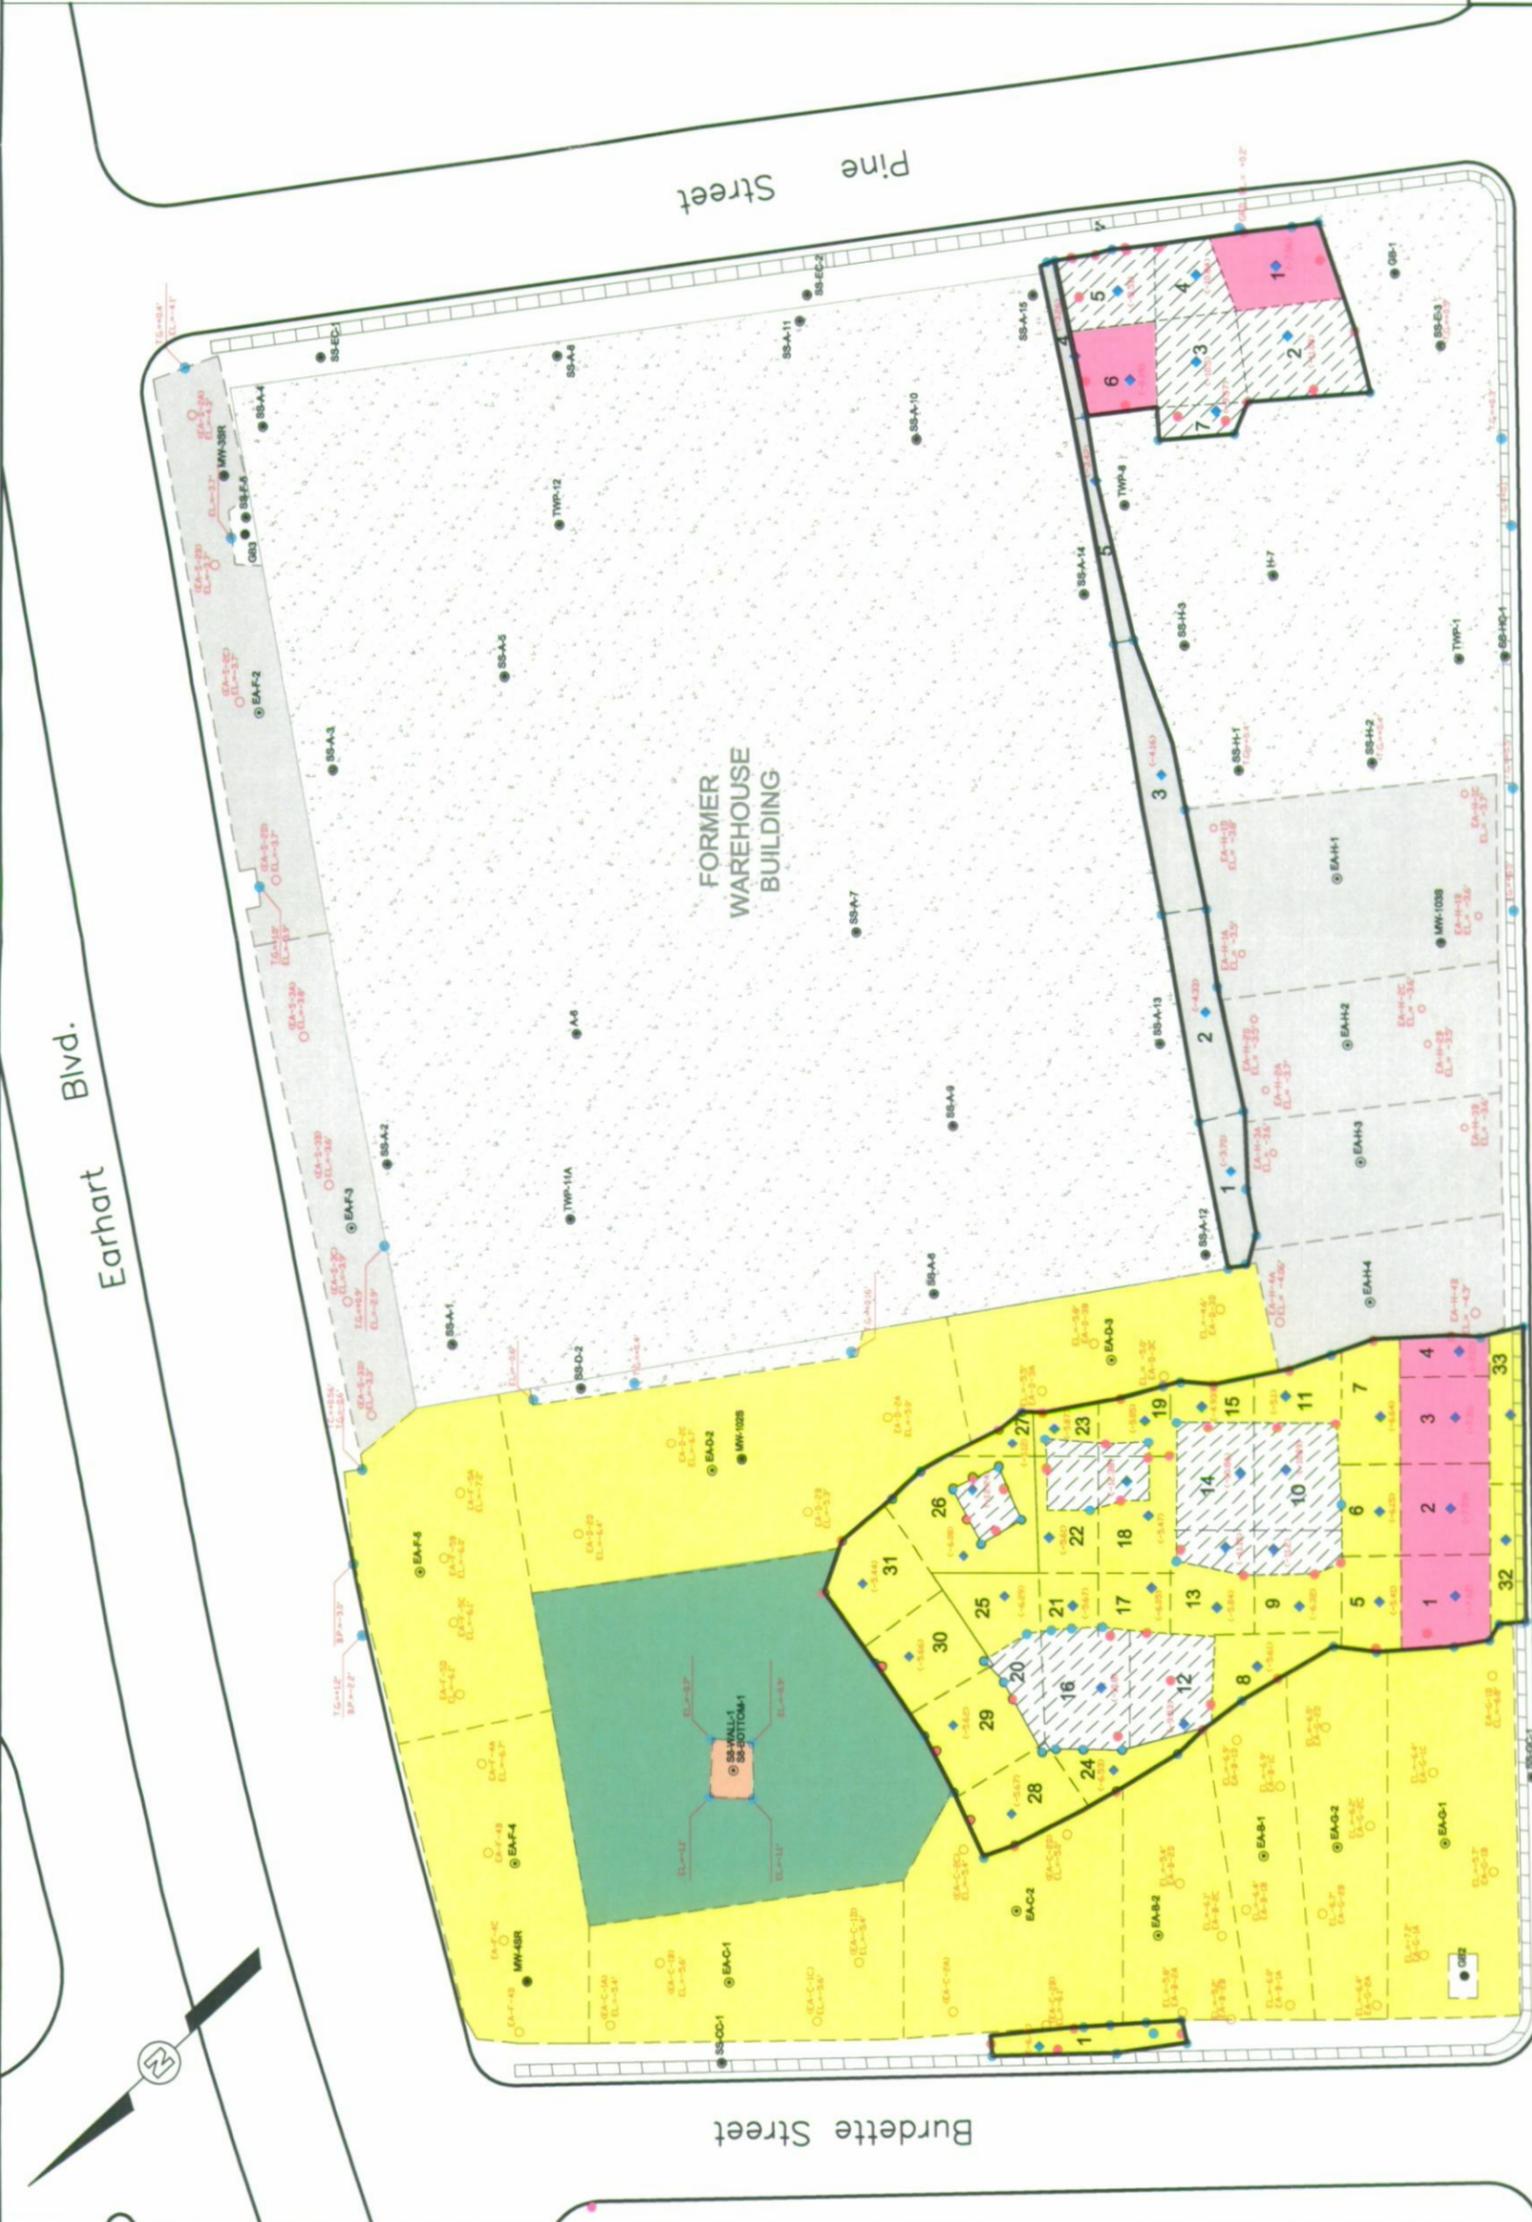
FIGURE 3-5
SURVEYED LIMITS OF EXCAVATION
REMEDIAL ACTIVITIES REPORT

- DELINEATION SOIL SAMPLE
- POST EXCAVATION CONFIRMATORY COMPOSITE BOTTOM SAMPLE (1990)
- 1990 COMPOSITE ALLOCATE AND BOTTOM SURVEY POINT
- SIDEWALL SAMPLE AND SURVEY POINT
- ◆ BOTTOM SAMPLE SURVEY POINT
- SURVEY CONTROL POINT
- 1990 EXCAVATION BOUNDARY
- 2007 EXCAVATION BOUNDARY
- HORIZONTAL LIMITS OF 2007 EXCAVATION
- SAMPLE GRID BOUNDARY
- 1 EXCAVATION AREA GRID NUMBER
- NOMIAL 1 ft. bgs EXCAVATION
- NOMIAL 2.0 - 3.0 ft. bgs EXCAVATION
- NOMIAL 3.0 - 5.0 ft. bgs EXCAVATION
- NOMIAL 5.0 - 7.0 ft. bgs EXCAVATION
- NOMIAL 7.0 - 8.0 ft. bgs EXCAVATION
- NOMIAL 9.5 ft. bgs EXCAVATION
- CONCRETE REMOVAL ONLY
- SIDEWALK

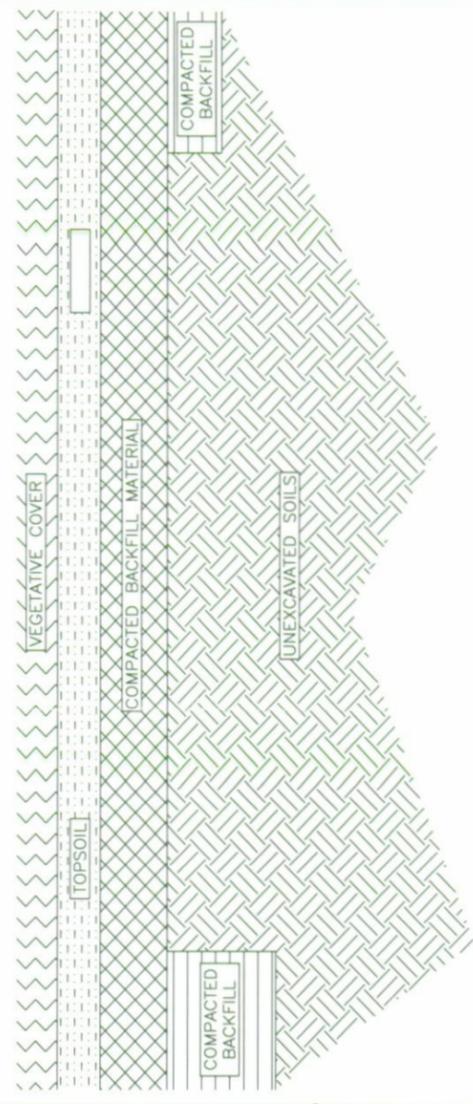
TYPICAL COVER DETAIL

Material used for topsoil was obtained from the Bonne Carre Spillway and consisted primarily of a silt and clay mixture. Geotechnical and chemical analyses were performed on the topsoil source prior to the introduction of the material to the site. Analytical and geotechnical analysis results from the collected backfill samples can be found in Appendix L. Photographic documentation of topsoil and grading operations are included in the photo log included as Appendix B. A final grading as built map is included as Figure 5-1.
